Health Safety & Fire Risk Assessment

Feltham Court

19-23 Hanworth Road

Report reference No: HSF64370/0022/300925/1

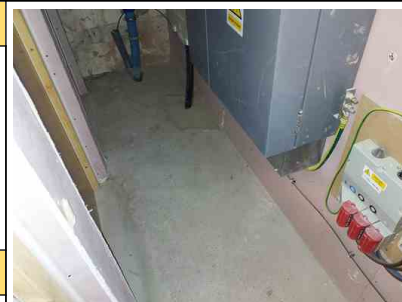
3.5 Action Plan - Health, Safety & Fire Risk/Hazards Risk/Hazard				
Site Address	Feltham Court 19-23 Hanworth Road Feltham TW13 5AF	Risk No/Type	E03	H&S
		Assessor	Gary Hendry	
		Date	30/09/2025	
		Responsible Person	Feltham Court Management Ltd

No electrical safety matting installed beneath electrical equipment.

Potential for electric shock.

Relevant guidance/best practice recommends that a form of insulation/protection against electric shock is provided below electrical equipment, so ensure that any electrical contractor who carries out work on the system provides their own suitable matting.

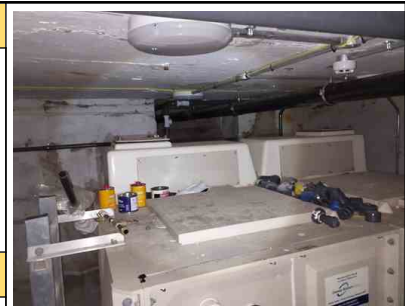
3.5 Action Plan - Health, Safety & Fire Risk/Hazards Risk/Hazard				
Site Address	Feltham Court 19-23 Hanworth Road Feltham TW13 5AF	Risk No/Type	EL01	H&S
		Assessor	Gary Hendry	
		Date	30/09/2025	
		Responsible Person	Feltham Court Management Ltd

No emergency lighting with insufficient borrowed lighting available.

Potential to cause serious injury and to hinder an evacuation from the building in the event of an emergency situation or failure of the main electrical power supply.

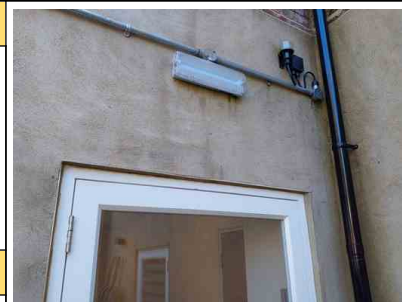
3.5 Action Plan - Health, Safety & Fire Risk/Hazards Risk/Hazard				
Site Address	Feltham Court 19-23 Hanworth Road Feltham TW13 5AF	Risk No/Type	EL03	H&S
		Assessor	Gary Hendry	
		Date	30/09/2025	
		Responsible Person	Feltham Court Management Ltd

Emergency light inoperative i.e. LED not armed.

Potential to cause serious injury and to hinder an evacuation from the building in the event of an emergency situation or failure of the main electrical power supply.

Employ a qualified, competent and 3rd party accredited contractor to repair / replace the emergency light unit.

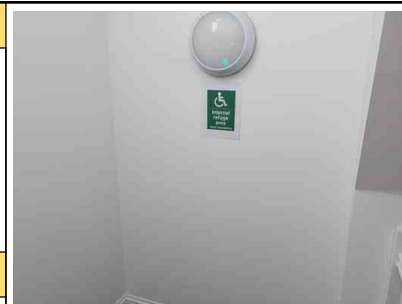
3.5 Action Plan - Health, Safety & Fire Risk/Hazards Risk/Hazard				
Site Address	Feltham Court 19-23 Hanworth Road Feltham TW13 5AF	Risk No/Type	EVC01	H&S
		Assessor	Gary Hendry	
		Date	30/09/2025	
		Responsible Person	Feltham Court Management Ltd

No EVC system at refuge points.

Potential to delay/hinder the safe evacuation of disabled persons in the event of an emergency.

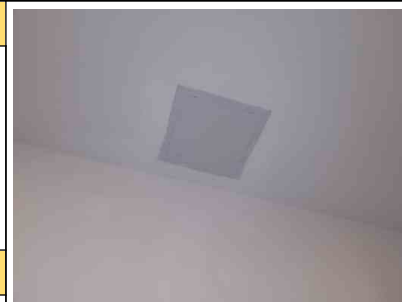
3.5 Action Plan - Health, Safety & Fire Risk/Hazards Risk/Hazard				
Site Address	Feltham Court 19-23 Hanworth Road Feltham TW13 5AF	Risk No/Type	FBS02	Fire
		Assessor	Gary Hendry	
		Date	30/09/2025	
		Responsible Person	Feltham Court Management Ltd

The ceiling inspection hatches installed are unlikely to offer the minimum ½ hour standard of fire resistance.

Potential for smoke, heat & fire to spread throughout the property.

Employ a qualified, competent and 3rd party accredited contractor to carry out a survey of this partitioning & to carry out the required remedial works to upgrade or replace the hatches so that they provide a minimum ½ hour standard of fire resistance.

Maintain partitions in good repair.

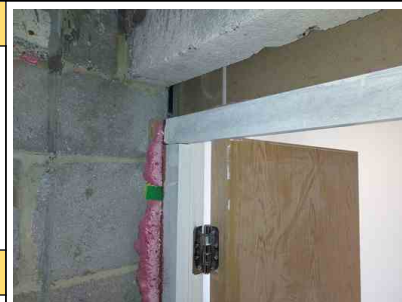
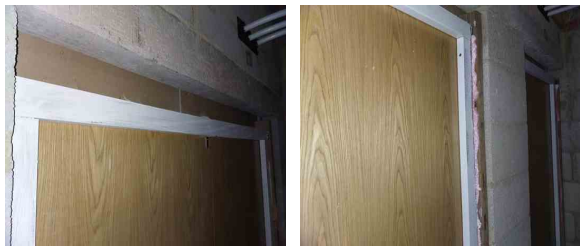
3.5 Action Plan - Health, Safety & Fire Risk/Hazards Risk/Hazard				
Site Address	Feltham Court 19-23 Hanworth Road Feltham TW13 5AF	Risk No/Type	FBS03g	Fire
		Assessor	Gary Hendry	
		Date	30/09/2025	
		Responsible Person	Feltham Court Management Ltd

Fire door frame has not been suitably fire stopped to the structural opening.

Potential for fire, heat and smoke to spread through the property.

Employ a qualified and competent third party accredited contractor to install suitable fire stopping around the door frame. Fire stopping works should be subject to regular inspections (no longer than annual) to monitor condition with suitable records maintained.

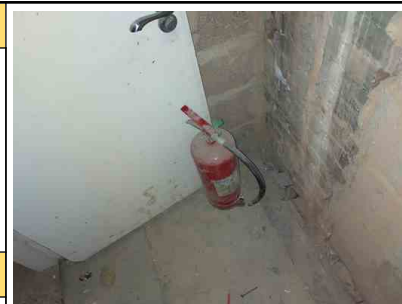
3.5 Action Plan - Health, Safety & Fire Risk/Hazards Risk/Hazard				
Site Address	Feltham Court 19-23 Hanworth Road Feltham TW13 5AF	Risk No/Type	FEX08	Fire
		Assessor	Gary Hendry	
		Date	30/09/2025	
		Responsible Person	Feltham Court Management Ltd

Obsolete fire extinguishers incorrectly stored.

Potential for confusion that could lead to this equipment being mistaken for suitably serviced units.

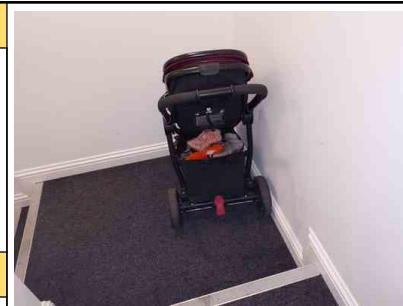
3.5 Action Plan - Health, Safety & Fire Risk/Hazards Risk/Hazard				
Site Address	Feltham Court 19-23 Hanworth Road Feltham TW13 5AF	Risk No/Type	FMES01	Fire
		Assessor	Gary Hendry	
		Date	30/09/2025	
		Responsible Person	Feltham Court Management Ltd

Fire exit/escape route partially blocked by stored items.

Potential to hinder evacuation of the building in the event of an emergency.

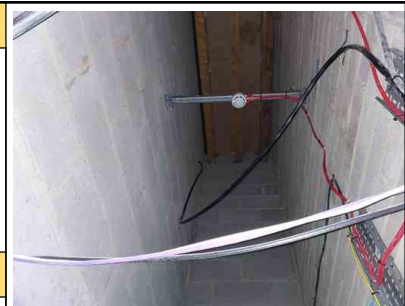
3.5 Action Plan - Health, Safety & Fire Risk/Hazards Risk/Hazard				
Site Address	Feltham Court 19-23 Hanworth Road Feltham TW13 5AF	Risk No/Type	FSD06	Fire
		Assessor	Gary Hendry	
		Date	30/09/2025	
		Responsible Person	Feltham Court Management Ltd

The smoke detector installed is poorly positioned away from recessed ceiling area. Potential for delay in raising the alarm as smoke would need to completely fill the recessed area of ceiling before the detector was activated and alarm was raised.

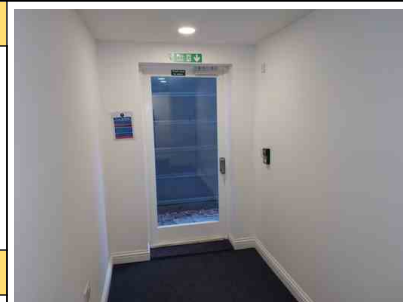
3.5 Action Plan - Health, Safety & Fire Risk/Hazards Risk/Hazard				
Site Address	Feltham Court 19-23 Hanworth Road Feltham TW13 5AF	Risk No/Type	G03	H&S
		Assessor	Gary Hendry	
		Date	30/09/2025	
		Responsible Person	Feltham Court Management Ltd

No form of manifestation on glazing.

Potential for persons to walk into glazing and sustain cuts/puncture injury.

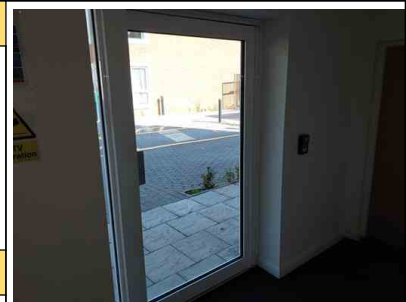
3.5 Action Plan - Health, Safety & Fire Risk/Hazards Risk/Hazard				
Site Address	Feltham Court 19-23 Hanworth Road Feltham TW13 5AF	Risk No/Type	G03 (1)	H&S
		Assessor	Gary Hendry	
		Date	30/09/2025	
		Responsible Person	Feltham Court Management Ltd

No form of manifestation on glazing.

Potential for persons to walk into glazing and sustain cuts/puncture injury.

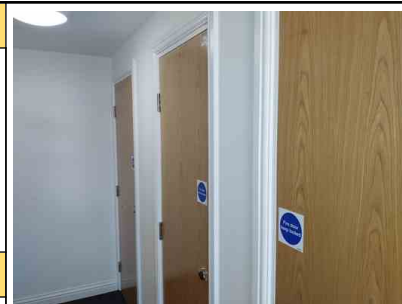
3.6 Action Plan - Health, Safety & Fire Risk/Hazards Risk/Hazard				
Site Address	Feltham Court 19-23 Hanworth Road Feltham TW13 5AF	Risk No/Type	E02	H&S
		Assessor	Gary Hendry	
		Date	30/09/2025	
		Responsible Person	Feltham Court Management Ltd

No electrical hazard information/voltage signage displayed on the electrical intake cupboard doors.

Purchase electric hazard signs & if required, employ a qualified, competent and 3rd party accredited contractor to install them on the electrical intake cupboard doors, as required.

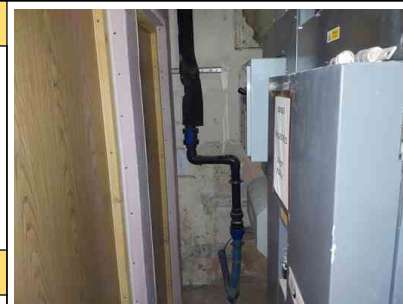
3.6 Action Plan - Health, Safety & Fire Risk/Hazards Risk/Hazard				
Site Address	Feltham Court 19-23 Hanworth Road Feltham TW13 5AF	Risk No/Type	E05	H&S
		Assessor	Gary Hendry	
		Date	30/09/2025	
		Responsible Person	Feltham Court Management Ltd

No electric shock poster.

Potential to delay the treatment of medical aid.

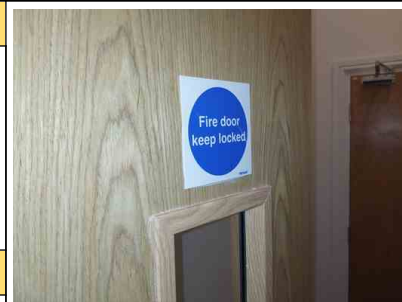
Inside of fire Doors not labelled "Fire Door Keep Closed". Incorrect fire door keep locked signage has been installed.

Potential for fire door to be left open and for fire & smoke to spread through the property.

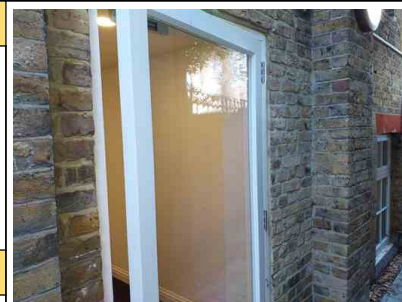
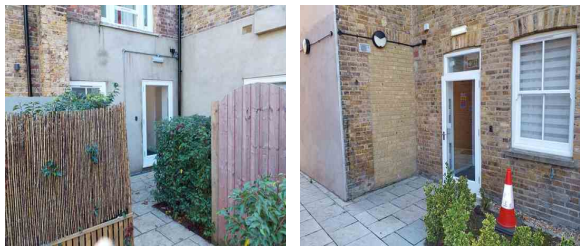
External side of final fire exit door does not display "Fire Exit Keep Clear" signage.

Potential to hinder evacuation of building in the event of an emergency.

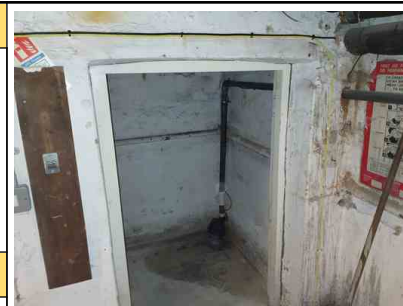
3.6 Action Plan - Health, Safety & Fire Risk/Hazards Risk/Hazard				
Site Address	Feltham Court 19-23 Hanworth Road Feltham TW13 5AF	Risk No/Type	PE01	H&S
		Assessor	Gary Hendry	
		Date	30/09/2025	
		Responsible Person	Feltham Court Management Ltd

Low-level building structure.

Potential for head injury.

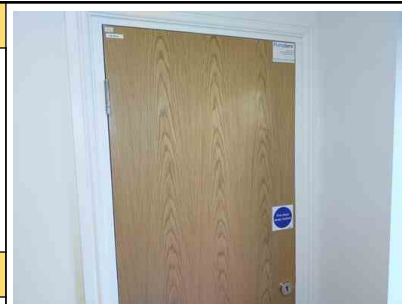
No prohibition sign displayed on plant room door.

Potential for unauthorised access to area with electrical/mechanical hazards present.
