# Fire Safety Risk Assessment

Bluebell Apartments  
Stockwood Gardens  
Newland Road  
Luton  
LU1 4GH

Bonum Safety Services Ltd  
on behalf of  
VIR Electrical Ltd

Assessment Date: 24<sup>th</sup> April 2026

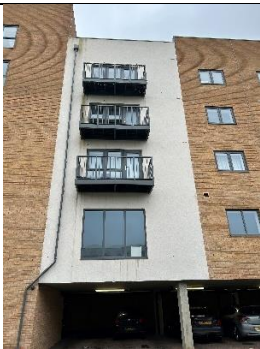
| <p>Example of balconies constructed of metal</p> | | <p>Example of cladding used on building. The responsible person must confirm fire stopping has been completed between floors behind the cladding and that the fascia material used will not facilitate fire spread. The cladding covers less than 25% of the façade and the building is under 6 storeys. An EWS 1 was completed in September 2020 and it stated no remedial works required.</p> | |

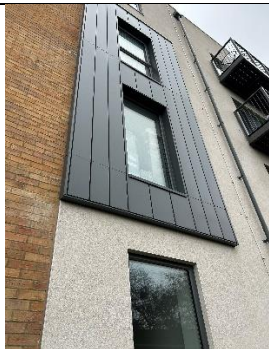
| HEIGHT OF BUILDING | YES / NO |
|---|---|
| Is a EWS1 Survey Required? | An EWS 1 survey was completed in September 2020 and the external cladding was graded as A2 and stated no remedial works are required. The building is under 18 meters and the cladding does not cover more than 25% of the façade. However, often mortgage companies still request one. |

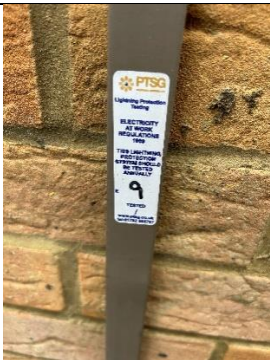
| Lightning protection tested annually by PTSG | | |

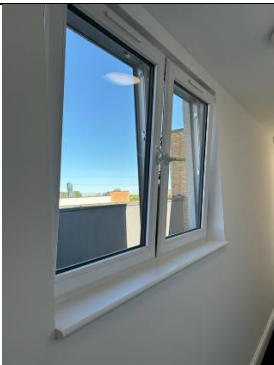
| AOV required in top floor corridor as detailed in letter from Bedfordshire Fire and Rescue Service dated 9 <sup>th</sup> April 2026. | | Evidence that the dry riser has been tested annually should be made available on request. | |

1. Install Automatic Smoke Vent on top floor corridor as highlighted in previous fire risk assessment and in the letter from Bedfordshire Fire and Rescue Service dated 9<sup>th</sup> April 2026.
2. Provide clear labels in the ground floor lobbies to indicate the lobby manual smoke control switches.
3. Produce a simple cause and effect schedule for the smoke control vents.

| ITEM # | ACTION | RISK RATING |
|---|---|---|
| 9. | <ul style="list-style-type: none"> <li>• Install Automatic Smoke Vent on top floor corridor as highlighted in previous fire risk assessment and in the letter from Bedfordshire Fire and Rescue Service dated 9th April 2026.</li> <li>• Provide clear labels in the ground floor lobbies to indicate the lobby manual smoke control switches.</li> <li>• Produce a simple cause and effect schedule for the smoke control vents.</li> </ul> | Moderate |
