# Fire Safety Risk Assessment

Chestnut Apartments  
4 Gorse Road  
Stockwood Gardens  
Luton  
Bedfordshire  
LU1 4GG

Assessment Date: 23<sup>rd</sup> February 2026

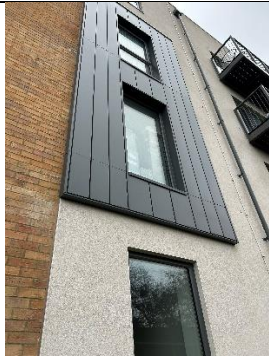
| <p>Chestnut Apartments</p> | | <p>Example of cladding used on building. The responsible person must confirm fire stopping has been completed between floors behind the cladding and that the fascia material used will not facilitate fire spread. The cladding covers less than 25% of the façade and the building is under 6 storeys</p> | |

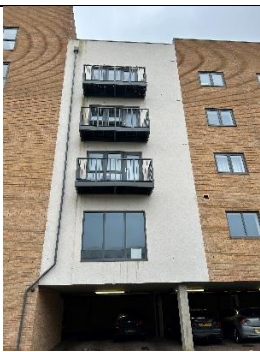
| <p>Example of balconies constructed of metal</p> | | | |

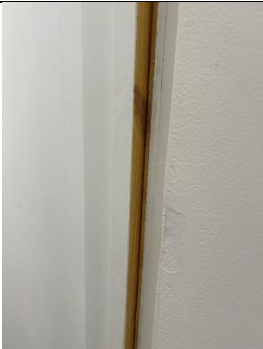
Fire doors to lobbies and communal areas are fitted with intumescent strips and smoke seals and most were operating effectively at the time of the assessment. On inspection some faults were noted which had not been rectified. The last fire door inspection for the communal areas was dated December 2025. The lobby and communal doors should be inspected every 3 months and any actions noted completed as soon as reasonably practicable.

| <p>Example of missing cold smoke seal on lobby fire door</p> | <p>Unknown screw in intumescent strip.</p> |

1. The communal fire doors should have a three month fire door inspection completed and any actions noted should be completed as soon as reasonably practicable. A record should be maintained of these 3 monthly checks.
2. The apartment front doors should have an annual inspection completed and any actions noted should be completed as soon as reasonably practicable. A record should be maintained of these 12 monthly checks.

| ITEM # | ACTION | RISK RATING |
|---|---|---|
| 3. | The communal fire doors should have a three month fire door inspection completed and any actions noted should be completed as soon as reasonably practicable. Records should be kept of the inspections. | Substantial |

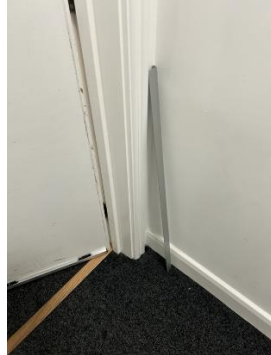
| <p>Example of missing cold smoke seal on lobby fire door</p> | <p>Example of missing bottom door seal on lobby fire door</p> |
