# Fire Safety Risk Assessment

## (Type One)

Ivy Apartments  
7 Gorse Road  
Stockwood Gardens  
Luton  
Bedfordshire  
LU1 4GL

Assessment Date: 23<sup>rd</sup> February 2026

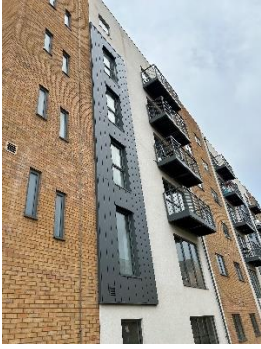
| <p>Ivy Apartments</p> | <p>Example of cladding used on building. The responsible person must confirm fire stopping has been completed between floors behind the cladding and that the fascia material used will not facilitate fire spread. The cladding covers less than 25% of the façade.</p> |

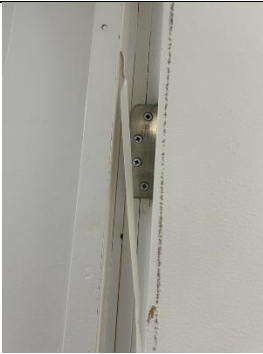
| <p>Example of faults noted on communal lobby fire doors which should be rectified as soon as reasonably practical</p> | <p>Example of faults noted on communal lobby fire doors which should be rectified as soon as reasonably practical</p> |

1. The communal fire doors should have a three month fire door inspection completed and any actions noted should be completed as soon as reasonably practicable. A record should be maintained of these 3 monthly checks.
2. The apartment front doors should have an annual inspection completed and any actions noted should be completed as soon as reasonably practicable. A record should be maintained of these 12 monthly checks.

| ITEM # | ACTION | RISK RATING |
|---|---|---|
| 3. | The communal fire doors should have a three month fire door inspection completed and any actions noted should be completed as soon as reasonably practicable. Records should be kept of the inspections. | Substantial |

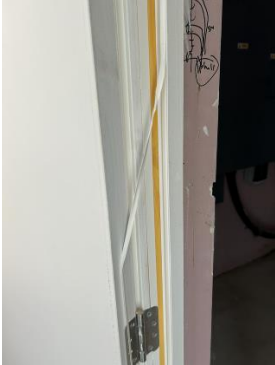
| <p>Example of faults noted on communal lobby fire doors which should be rectified as soon as reasonably practical</p> | <p>Firefighting lift should be inspected and tested monthly and findings recorded</p> |

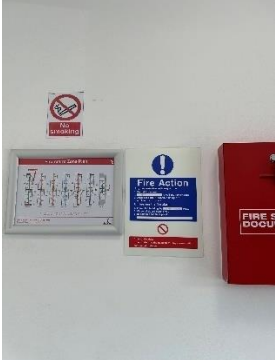
| <p>Example of the incorrect fire action notice as a stay put policy is in place and also no fire extinguishers are provided or required</p> | <p>An AOV system next to the firefighting lift. This should be inspected as required along with all the AOV systems</p> |

| Do signs indicate all escape routes and final exits? | Are panic bar release type doors fitted with "Push Bar to open" signs? | Are the external sides of final exit doors fitted with a sign to prevent obstruction where appropriate? | Are fire doors fitted with the correct signage? | Are fire action notices displayed at every fire alarm call point? | Does the contents of the fire action notice reflect the actual procedure? |
|---|---|---|---|---|---|
| <p><b>Comments:</b></p> <p>The premises does have escape route signage to inform residents and members of the public on the escape routes.</p> <p>The fire doors in the premises and storage cupboards are signed appropriately with "Fire Door Keep Shut" and "Fire Door Keep Locked" signs.</p> <p>The sprinkler room on the ground floor should have a sign denoting it is a sprinkler room.<br/>The electrical intake plant room should have a warning sign regards the electrical risk.<br/>Comprehensive fire safety information supplied to residence.</p> <p>Replace incorrect fire action notices.</p> <p><b>Actions:</b></p> <ul style="list-style-type: none"> <li>• Sprinkler room signed appropriately</li> <li>• Electrical intake rooms signed appropriately</li> <li>• Replace incorrect Fire Action notices</li> </ul> | | | | | |
