# Fire Safety Risk Assessment

Juneberry & Blackthorn Apartments  
Stockwood Gardens  
Newland Road  
Luton  
LU1 4GH

Assessment Date: 24<sup>th</sup> April 2026

# Juneberry & Blackthorn Apartments

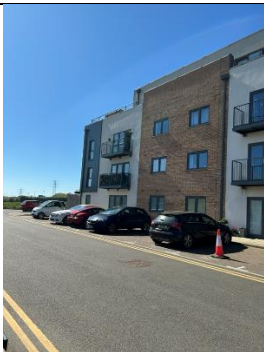
| Example of one of the exits | Example of cladding used on building. The responsible person must confirm fire stopping has been completed between floors behind the cladding and that the fascia material used will not facilitate fire spread. The cladding covers less than 25% of the façade and the building is under 6 storeys. An EWS 1 was completed in September 2020 and it stated no remedial works required |

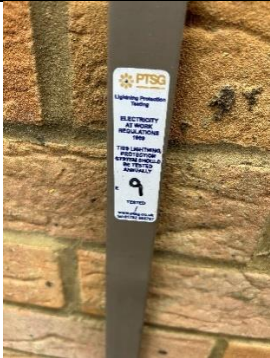
Lightning protection tested needs to be evidenced.

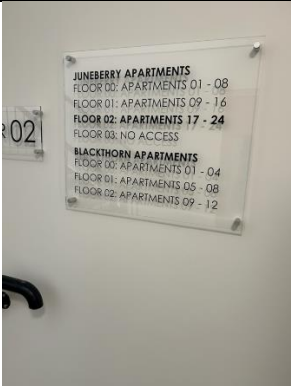
| <p>Some of the cupboard doors are missing smoke seals. These should be fitted to all doors that open onto the communal area</p> | <p>Floor layout</p> |

- The communal fire doors should have a three month fire door inspection completed and any actions noted should be completed as soon as reasonably practicable. A record should be maintained of these 3 monthly checks.
- The apartment front doors should have an annual inspection completed and any actions noted should be completed as soon as reasonably practicable. A record should be maintained of these 12 monthly checks.
- All fire doors that open into the communal area should have smoke seals fitted.

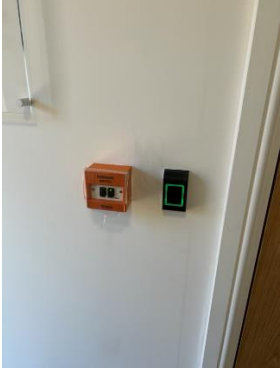
| <p>AOV should be labelled and a cause and effect schedule prepare by fire engineer</p> | <p>PIB box fitted in lobby</p> |

1. Provide clear labels in the ground floor lobbies to indicate the lobby manual smoke control switches serve the staircase AOV's.
2. In liaison with your competent fire alarm engineer, produce a simple cause and-effect schedule that confirms activation sequences of smoke control vents or any other devices interfaced with the fire alarm system.

| | <ul style="list-style-type: none"><li>In liaison with your competent fire alarm engineer, produce a simple cause and-effect schedule that confirms activation sequences of smoke control vents or any other devices interfaced with the fire alarm system.</li></ul> | |
