# Fire Safety Risk Assessment

Snowdrop Apartments  
5 Gorse Road  
Stockwood Gardens  
Luton  
Bedfordshire  
LU1 4GH

Bonum Safety Services Ltd  
on behalf of  
VIR Electrical Ltd

Assessment Date: 23<sup>rd</sup> February 2026

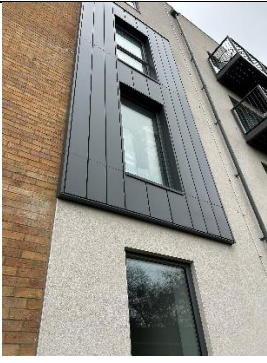
There is a small area of cladding at the front of the building for decorative purposes. This appears to be metal framed with metal board fascia. It covers an area approximately 15m squared. The assessor has requested information on the materials fire resistance and if fire stopping between floors has been completed. However, none has been forthcoming. The area is not large but the Responsible person should confirm that fire stopping has been completed between floors to ensure it will not facilitate fire spread.

| <p>Snowdrop Apartments</p> | | <p>Example of cladding used on building. The responsible person must confirm fire stopping has been completed between floors behind the cladding and that the fascia material used will not facilitate fire spread</p> | |

| HEIGHT OF BUILDING | YES / NO |
|---|---|
| Is a EWS1 Survey Required? | NO. However the responsible person must confirm that any fire stopping behind the cladding and between floors has been carried out as required. |

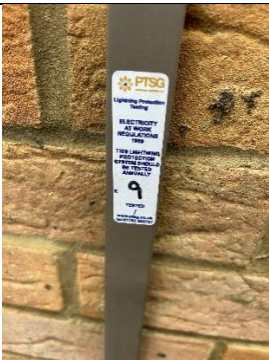
| Lightning protection tested annually by PTSG | | |

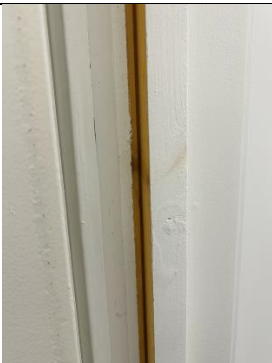
Fire doors to lobbies and communal areas are fitted with intumescent strips and smoke seals and most were operating effectively at the time of the assessment. On inspection some faults were noted which had not been rectified. The last fire door inspection for the communal areas was dated December 2025. The lobby and communal doors should be inspected every 3 months and any actions noted completed as soon as reasonably practicable.

| Example of damaged cold smoke seal on lobby fire door. | Missing cold smoke seal from lobby fire door. |

1. The communal fire doors should have a three month fire door inspection completed and any actions noted should be completed as soon as reasonably practicable. A record should be maintained of these 3 monthly checks.
2. The apartment front doors should have an annual inspection completed and any actions noted should be completed as soon as reasonably practicable. A record should be maintained of these 12 monthly checks.

| ITEM # | ACTION | RISK RATING |
|---|---|---|
| 3. | The communal fire doors should have a three month fire door inspection completed and any actions noted should be completed as soon as reasonably practicable. Records should be kept of the inspections. | Substantial |
