# Fire Safety Risk Assessment

## (Type One)

Thistle Apartments  
3 Gorse Road  
Stockwood Gardens  
Luton  
Bedfordshire  
LU1 4GF

Assessment Date: 23<sup>rd</sup> February 2026

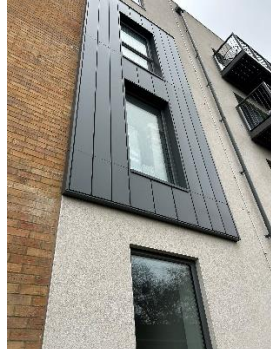
| <p>Thistle Apartments</p> | | <p>Example of cladding used on building. The responsible person must confirm fire stopping has been completed between floors behind the cladding and that the fascia material used will not facilitate fire spread. The cladding covers less than 25% of the façade and the building is under 6 storeys</p> |

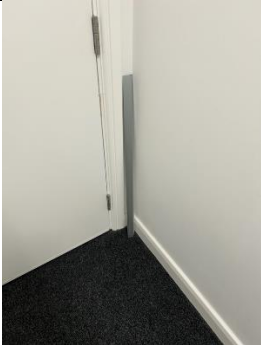
Fire doors to lobbies and communal areas are fitted with intumescent strips and smoke seals and most were operating effectively at the time of the assessment. On inspection some faults were noted which had not been rectified. The last fire door inspection for the communal areas was dated December 2025. The lobby and communal doors should be inspected every 3 months and any actions noted completed as soon as reasonably practicable.

| Example of missing cold smoke seal | | Missing bottom door seal | |
| Example of damaged cold smoke seal | | | |

1. The communal fire doors should have a three month fire door inspection completed and any actions noted should be completed as soon as reasonably practicable. A record should be maintained of these 3 monthly checks.
2. The apartment front doors should have an annual inspection completed and any actions noted should be completed as soon as reasonably practicable. A record should be maintained of these 12 monthly checks.

| ITEM # | ACTION | RISK RATING |
|---|---|---|
| 3. | The communal fire doors should have a three month fire door inspection completed and any actions noted should be completed as soon as reasonably practicable. Records should be kept of the inspections. | Substantial |
