# Fire Safety Risk Assessment

White Rose Apartments  
2 Gorse Road  
Stockwood Gardens  
Luton  
Bedfordshire  
LU1 4Ge

Bonum Safety Services Ltd  
on behalf of  
VIR Electrical Ltd

Assessment Date: 23<sup>rd</sup> February 2026

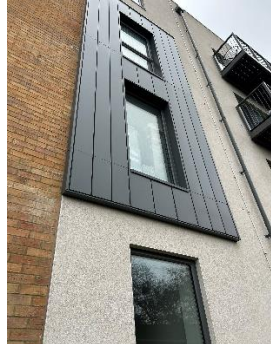
| <p>Example of balconies constructed of metal</p> | | <p>Example of cladding used on building. The responsible person must confirm fire stopping has been completed between floors behind the cladding and that the fascia material used will not facilitate fire spread. The cladding covers less than 25% of the façade and the building is under 6 storeys</p> | |

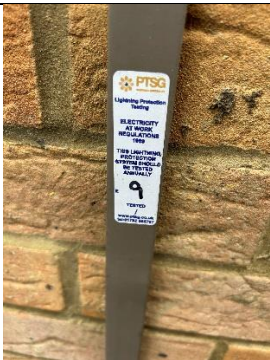
| Lightning protection tested annually by PTSG | |

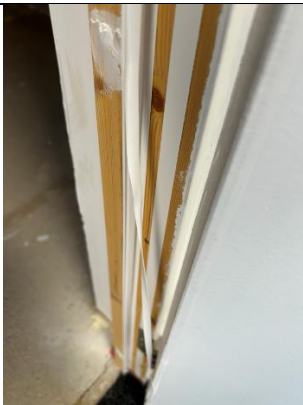
Fire doors to lobbies and communal areas are fitted with intumescent strips and smoke seals and most were operating effectively at the time of the assessment. On inspection some faults were noted which had not been rectified. The last fire door inspection for the communal areas was dated December 2025. The lobby and communal doors should be inspected every 3 months and any actions noted completed as soon as reasonably practicable.

| Example of damaged bat wing smoke seal on fire door | Unsuitable items in waste storage area should be removed |

- The communal fire doors should have a three month fire door inspection completed and any actions noted should be completed as soon as reasonably practicable. A record should be maintained of these 3 monthly checks.
- The apartment front doors should have an annual inspection completed and any actions noted should be completed as soon as reasonably practicable. A record should be maintained of these 12 monthly checks.

| ITEM # | ACTION | RISK RATING |
|---|---|---|
| 3. | The communal fire doors should have a three month fire door inspection completed and any actions noted should be completed as soon as reasonably practicable. Records should be kept of the inspections. | Substantial |
