# Health Safety & Fire Risk Assessment

## Boulevard View Management Ltd

Undertaken at  
**Boulevard View  
Whitchurch Lane  
Bristol  
BS14 0BB**

**Report reference No: HSF64370/0018/071025/1**

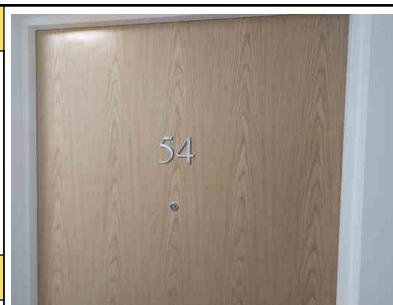
3.5 Action Plan - Health, Safety & Fire Risk/Hazards Risk/Hazard				
<b>Site Address</b>	Boulevard View Whitchurch Lane Bristol BS14 0BB	<b>Risk No/Type</b>	<b>FD16</b>	<b>Fire</b>
		<b>Assessor</b>	Andre Merwe	
		<b>Date</b>	07/10/2025	
		<b>Responsible Person</b>	Boulevard View Management Ltd

Residential tenants demise main entry doors not seen / inspected. Unable to determine if the entry door to the tenants demise meets the minimum half hour standard of fire resistance.

Potential for fire, heat and smoke to spread into the communal area and compromise the escape route.

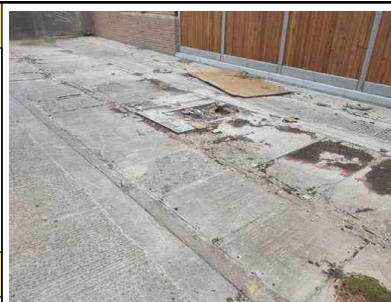
3.6 Action Plan - Health, Safety & Fire Risk/Hazards Risk/Hazard				
<b>Site Address</b>	Boulevard View Whitchurch Lane Bristol BS14 0BB	<b>Risk No/Type</b>	<b>BS09</b>	<b>H&amp;S</b>
		<b>Assessor</b>	Andre Merwe	
		<b>Date</b>	07/10/2025	
		<b>Responsible Person</b>	Boulevard View Management Ltd

The surface of the external path is in a poor condition in places. Potential trip hazard.

Monitor the external path for condition and damage as part of the building maintenance and inspection schedule.
