# Fire Safety Risk Assessment

## (Type One)

Heather Apartments  
Stockwood Gardens  
Newland Road  
Luton  
LU1 4GH

Assessment Date: 24<sup>th</sup> April 2026

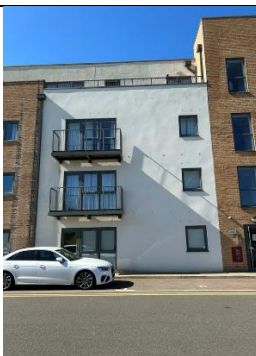
| <p>Example of balconies constructed of metal</p> | | <p>Waste store appeared well manged</p> |

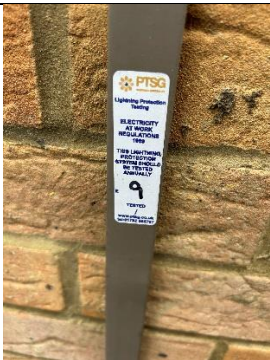
| <p>Lightning protection tested annually by PTSG</p> | | |

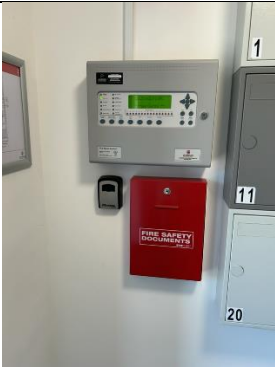
| <p>AOV should be labelled and a cause and effect schedule prepare by fire engineer.</p> | | <p>PIB boxes should contain necessary information and key must be provided for access by the fire service.</p> | |

1. Provide clear labels in the ground floor lobbies to indicate the lobby manual smoke control switches serve the staircase AOV's.
2. In liaison with your competent fire alarm engineer, produce a simple cause and-effect schedule that confirms activation sequences of smoke control vents or any other devices interfaced with the fire alarm system.

| | <ul style="list-style-type: none"><li>In liaison with your competent fire alarm engineer, produce a simple cause and-effect schedule that confirms activation sequences of smoke control vents or any other devices interfaced with the fire alarm system.</li></ul> | |
